37-42MT Solenoids Chattering???
Solenoid!

It's Not Always the

Tech Bulletin 02/04/11

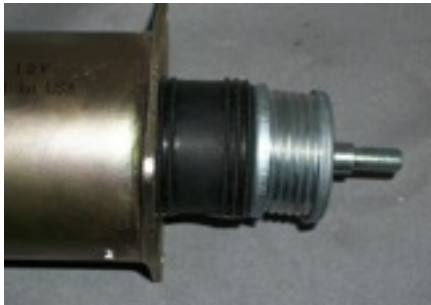
Notice how the spring is solid. Is the plunger seated? We can't tell. We can say that if the plunger is not seated, the solenoid can chatter. There is quite a bit of variation on this solenoid from the way the extruded washer is installed, so this makes the failure random and hard to find.

We are attempting to get good plungers in stock; our part number will be 105-DEP037A. Until then, we suggest checking your plunger spring. If you have to, you can shorten the extruded washer part of the solenoid by carefully grinding on it until there is some air gap in the spring, just to be sure.

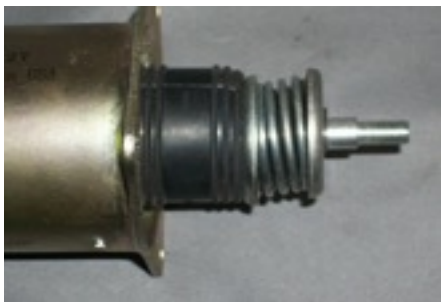
Here is a good plunger with one less turn on the spring and an air gap in the spring coils.
