19139 10-MI209

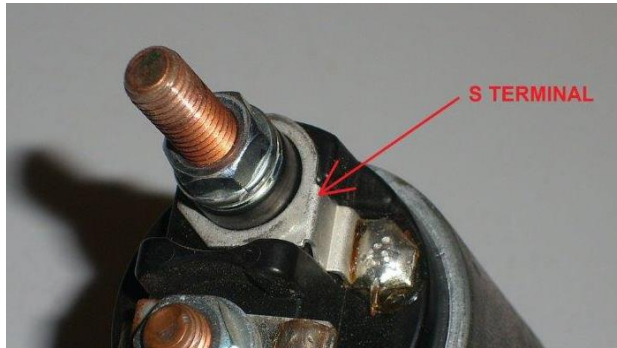
This solenoid has one unique features that may cause rebuilder and installers some easily corrected problems. The S terminal is the big ring around the b terminal. See Picture:

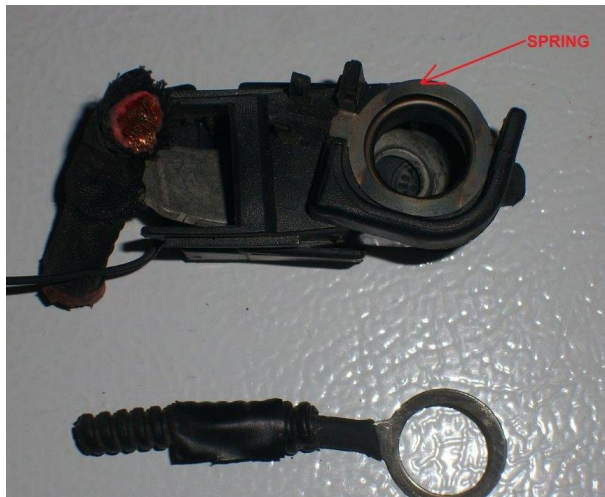
If the B+ plastic starter connection cover is damaged or the wave spring is rusted on the car this starter is installed on, the starter will not crank. The good thing is this plastic piece is available at a reasonable cost.

The part numbers for the starter connection cover is 68073159AA or 68119375AA. Current cost on internet is under \$5.00 I would recommend cleaning the terminal in the harness and a thin coat of dielectric silicone in high salt areas to prevent corrosion.
